Seal Rock Water District

General Manager's Report:

Board Meeting January 13, 2022

PHASE-IV BEAVER CREEK SOURCE WATER PROJECT:

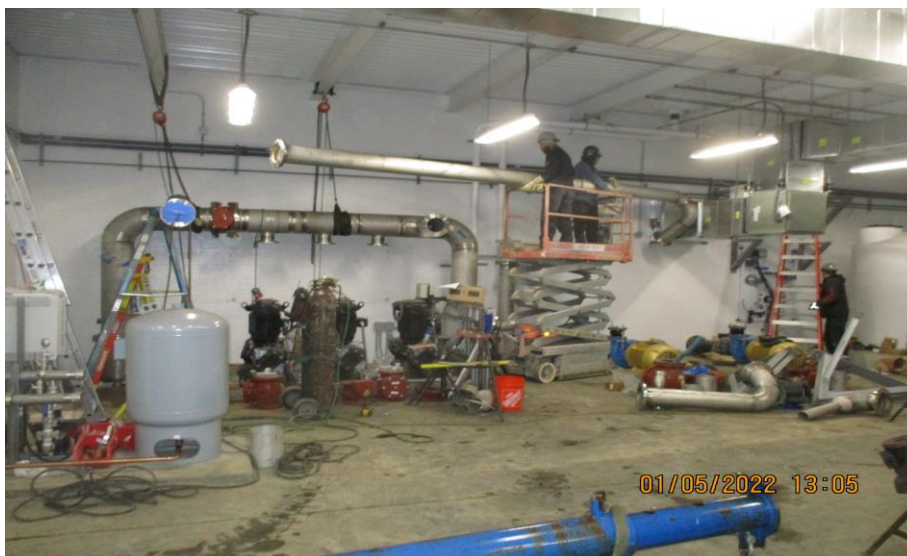
Membrane Building:

- o Pipe support installation
- o Anchorage of UF, CIP, and Neutralization tanks
- o Soffit and flashing installation, sheet metal closures, cap sheet metal flashing
- o Conduit, panel, and wiring for facility lighting, outlets, and switches
- o WesTech panel installation - Chemical feed panel installation
- o Plumbing installation of interior PVC pipes for CIP and chemical pipes
- o HVAC installation in the electrical room - Drywall and insulation of interior rooms
- o Electrical work pulling in wire from generator and transformer area
- o Door installation - Gutters and Downspouts - FW Pumps, piping installed in trench

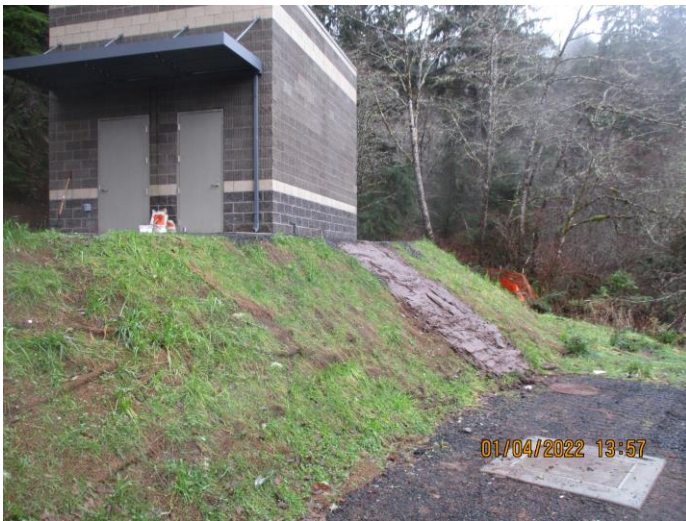
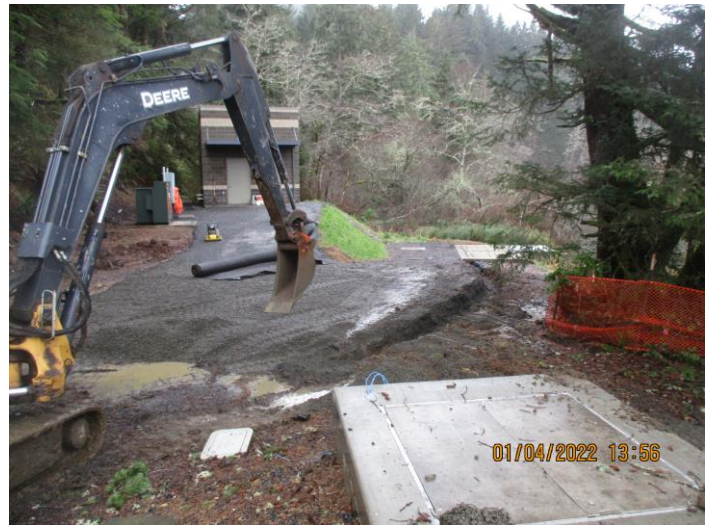
- **RW Intake Building:**

- o Overflow, roof drain, and eyewash station
- o Hydrostatic testing of 2" FW
- o Door installation

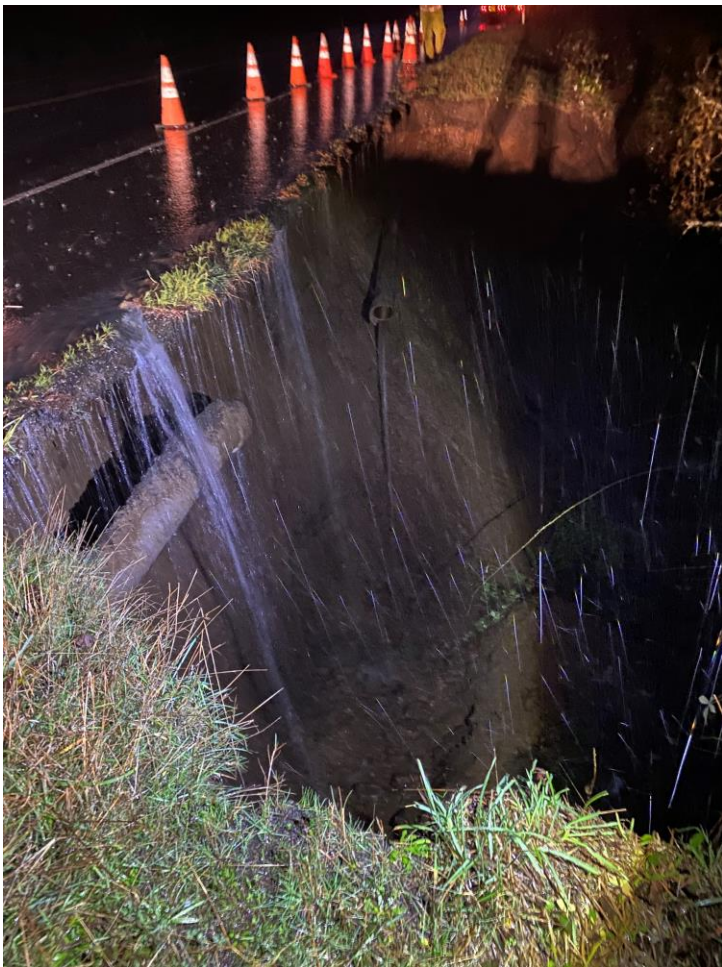
- 1.) In the early hours of December 20th, District crews were alerted to conditions of low pressure in the north end of the distribution system after a landslide, caused by heavy rain that occurred along HWY-101 across from the entrance to the Newport Airport. The landslide caused a section of 8-inch waterline to separate, which required a complete shutdown of the distribution system resulting in zero pressure conditions. District crews, assisted by R&G Excavation Inc. worked through the day installing isolation valves north and south of the slide area to temporarily restore service to the Newport Airport and approximately 30 customers affected by the outage.

US HWY 101 – MP 145: December 20, 2021, looking South.

As you can see by the photos the district will need to replace 300+ LF of water main to complete permanent repairs. ODOT engineers are designing slope stabilization design criteria and will be advertising a request for quotes to complete emergency repairs by a local contractor. ODOT representatives anticipate work to repair the hillside will be completed the first week of January. District crews are coordinating with R&G Excavation to complete permanent repairs to the distribution system in this area the week of January 10th.

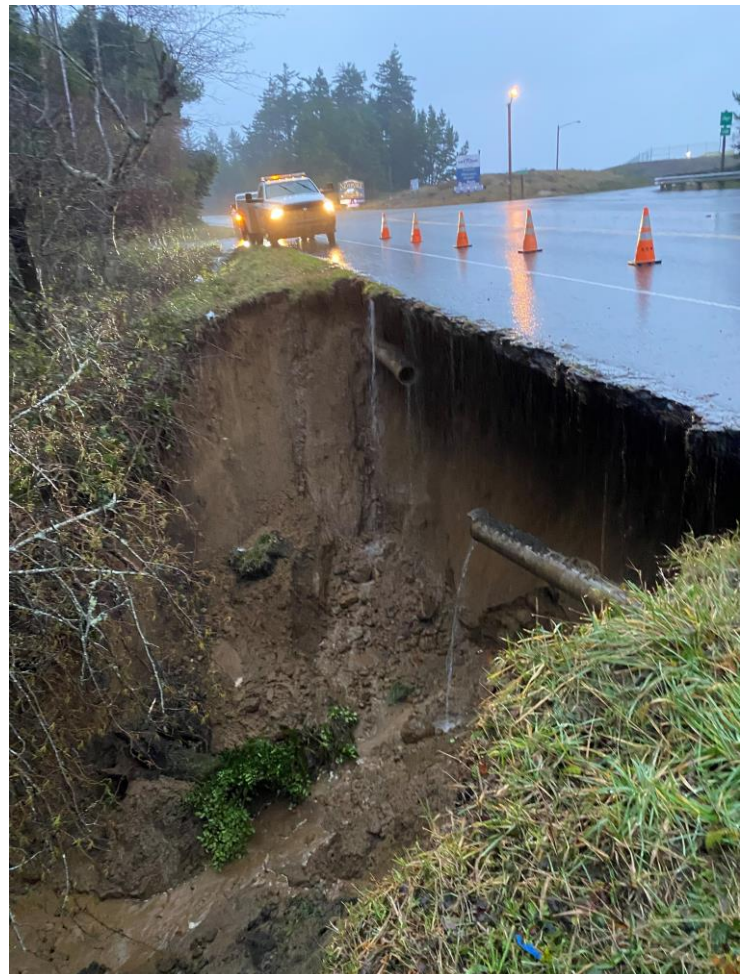
Looking North:

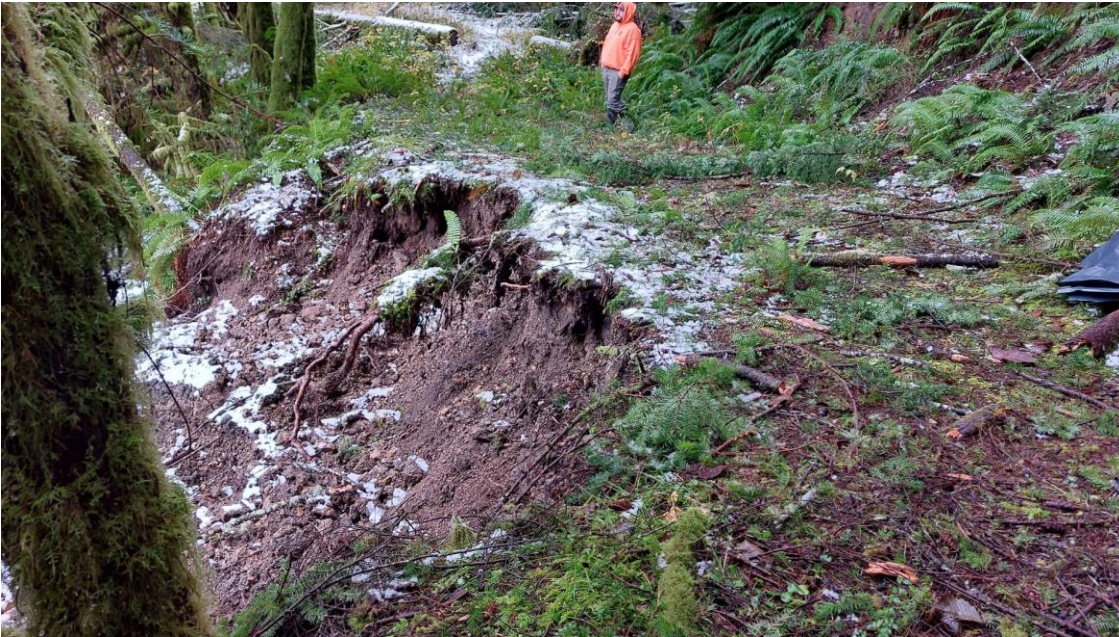
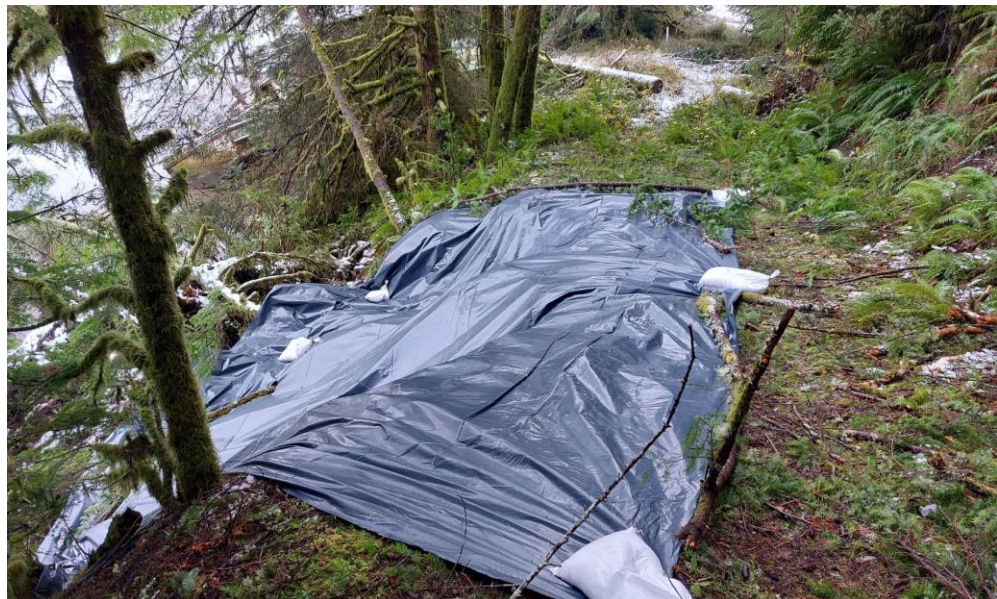
2.) While making routine rounds district crews discovered a second slide on the easement road through Freemans’s property adjacent to the Toledo supply line located near the Poole Slough crossing. This area is difficult to access and will require support from a contractor with specialized equipment. Fortunately, the district’s Toledo supply line has not been compromised. However, continuation of the slide has the potential to impact the district’s supply line. As you can see in the attached photos District crews have secured the area with heavy mill plastic and sandbags to prevent further erosion until permanent repairs can be completed. Permanent repairs in this area include replacing the section of waterline in the affected area and extending the pipe up the hill to the access road with approximately 600-LF of 14-inch HDPE.

Poole Slough slide December 23, 2021
