## Seal Rock Water District

General Manager's Report:  
 Board Meeting – October 10, 2024

### **PHASE-IV BEAVER CREEK SOURCE WATER:**

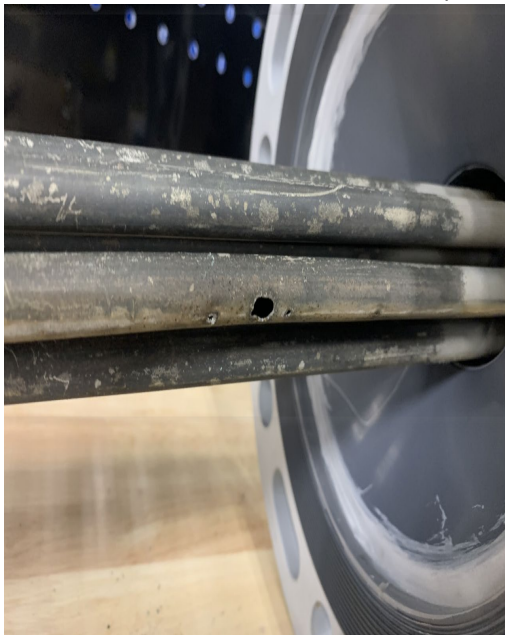
Originals: 18 months operation

- Chlorine cleans used 0.8% OSG system (high background chloride content)
- Failure shown is near the flange

District operators received a comprehensive metallurgist report provided by Phoenix National Laboratories, included with the Board Packets. There was notable magnesium (Mg), aluminum (Al), and sulfur (S) associated with the corrosion product along with chlorine (Cl). Chlorine is an aggressive species for stainless steel and with the amount of pitting, was probably the main culprit but the sulfur would also be another one to keep an eye on.

What we are discovering is that the application of the heater elements seems to be exposing them to chemicals during or after cleaning the membranes. Operators are engaged with Jacobs Engineers, WesTech Technicians, and Chromalox the manufacturer of the heating elements to evaluate system conditions and determine a path forward to resolve this issue. At present, the WTP is running on one of the three heaters which extends runtimes for performing routine membrane cleaning and maintenance. The district has ordered three new heating elements which will arrive in the next couple of weeks. However, at a cost of \$1,150.00 per element, operators are reluctant to install the new elements until this issue can be resolved.

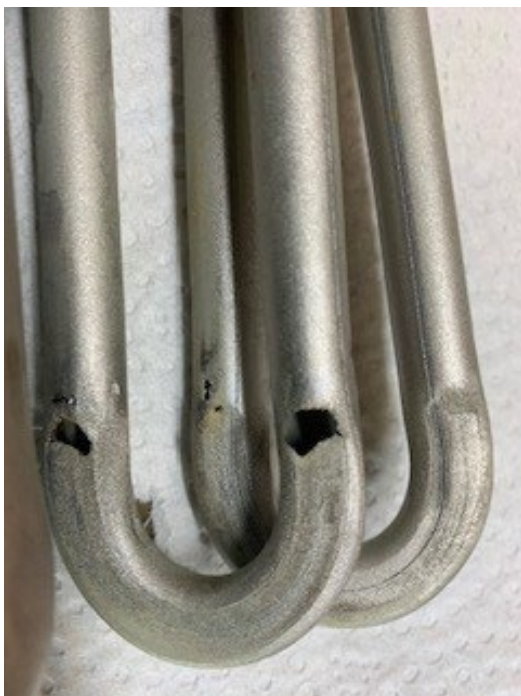
Replacements: 3-4 months operation

- Chlorine cleans used 12% sodium hypochlorite (very low background chloride content)
- Failure point shown is at the u-tube end (away from flange)
